ODI RESUME

Investigation: EA04-025
Prompted By: PE04-039
Date Opened: 08/26/2004 Date Closed: 12/22/2005
Principal Investigator: Scott Yon
Subject: False Park

Manufacturer: DaimlerChrysler Corporation
Products: 2003-2005 Dodge Ram 2500/3500 Diesel With Auto. Transmission
Population: 250,285

SUMMARY REPORT - ENGINEERING ANALYSIS (EA) 04-025**DATE OPENED:** August 25, 2004**DATE CLOSED:** December 22, 2005**SUBJECT:** False Park.**SUBJECT VEHICLES:** The scope of the investigation included 250,285 model year (MY) 2003 to 2005 Dodge Ram 2500/3500 pickups with diesel engines and automatic transmissions.**ALLEGED DEFECT:** The inadvertent powered rearward movement of the vehicle from a parked position, where the driver alleges the gearshift lever was in Park.**BASIS AND BACKGROUND:** Preliminary Evaluation (PE) 04-039 was opened in April 2004 and subsequently upgraded to EA04-025. The basis for investigation was Office of Defects Investigation (ODI) vehicle owner questionnaires (VOQs). Additionally, two prior investigations, EA96-006 and EA01-017, involved powered reverse rollaway incidents in DaimlerChrysler Corporation (DCC) vehicles that utilized transmissions of a similar design

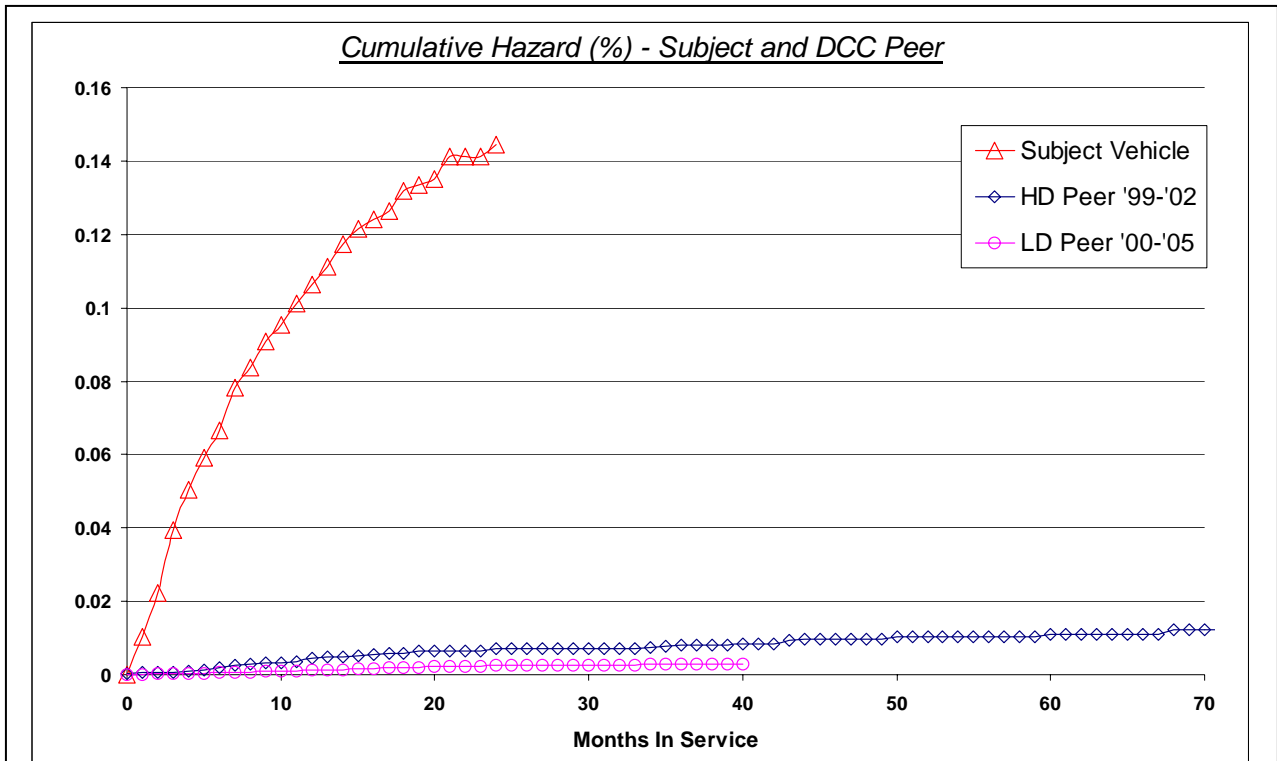
Figure 1: Subject and DCC Peer Cumulative Hazard Rates for Powered Reverse Rollaway Incidents as of July 20, 2005

ODI DISCUSSION: Figure 1 shows the cumulative hazard rate¹⁷ for powered rollaway incidents against vehicle age for the subject and DCC peer vehicles as of July 20, 2005. The Ford and GM peer vehicles are not shown on the chart because ODI did not identify any reports of rollaway incidents for these vehicles¹⁸. As noted in the chart, the SVs experience a higher incidence of powered reverse rollaway at a given vehicle age as compared to DCC vehicles.

does not believe that owner demographics, or ‘learned behaviors,’ represent an explanation for the disparity in rollaway rates which exist between the SV and peer vehicles, as shown in Figure 1.

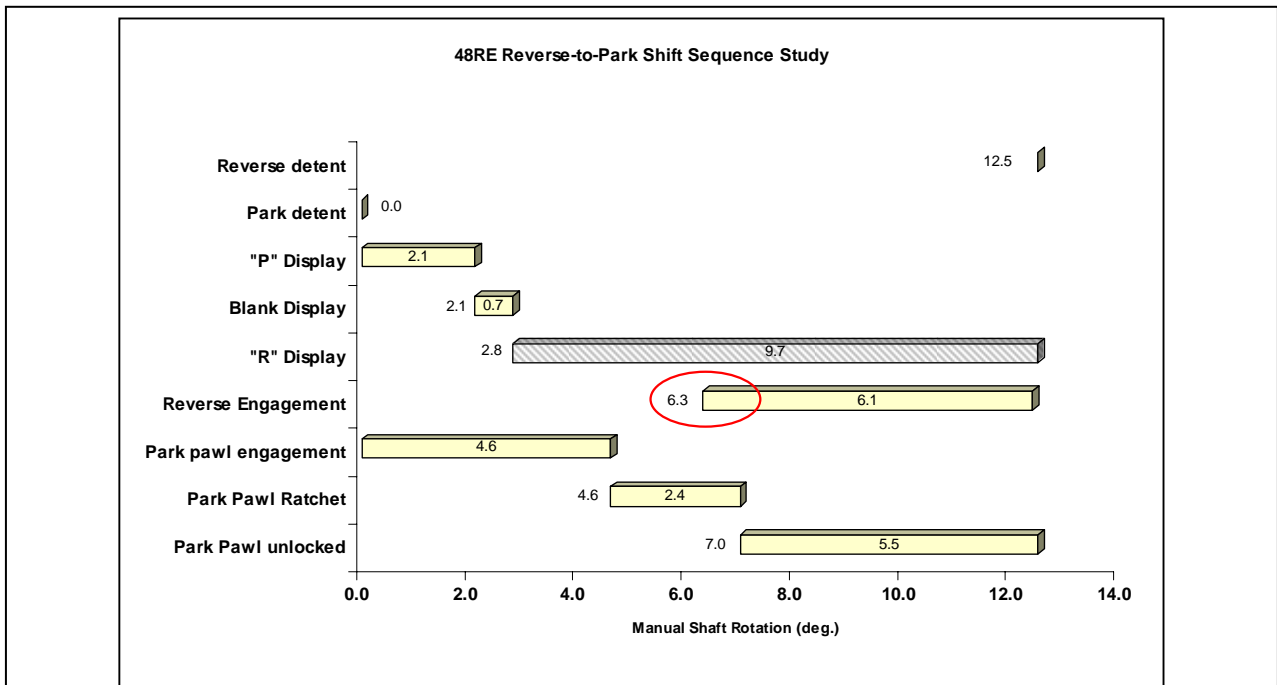
Figure 2: Subject Vehicle Shift Sequence – State versus Manual Shaft Position

DCC provided Figure 2, which shows the state of the PRNDL, reverse gear hydraulic circuit, and park pawl versus manual shaft position when rotation from Reverse to Park occurs¹⁹. For example, starting from the detent Park position²⁰, the chart shows that the “P” indicator of the PRNDL will be illuminated through 2.1 degrees of manual shaft rotation, followed by a blank PRNDL for the next 0.7 degrees, then “R” display for the next 9.7 degrees, etc. Notably, the chart shows that hydraulic reverse²¹ pressurization occurs at approximately 6.3 degrees of rotation (area highlighted by red circle); at this position the park pawl is neither engaged, nor unlocked. When an operator places the manual shaft at or near this position, a hydraulic valve bleed condition occurs at the spool valve within the valve body. The valve bleed results in a transient charging of the reverse hydraulic circuit (due to restricted fluid flow) and a coincident delay in hydraulic reverse engagement. At this position, the park pawl is not engaged and the output shaft is not locked, thus vehicle movement is possible²². When the vehicle is stopped on a flat and level surface, the delay period the valve bleed condition produces, if sufficiently long, present a false sense of Park to the operator and may allow the operator to exit the vehicle prior to vehicle movement becoming apparent²³. Therefore, the susceptibility of the shift system to be inadvertently placed in an intermediate or incomplete shift

state between Park and Reverse exists and is a critical factor in whether rollaway incidents, such as those experienced by the SVs, are likely to occur.

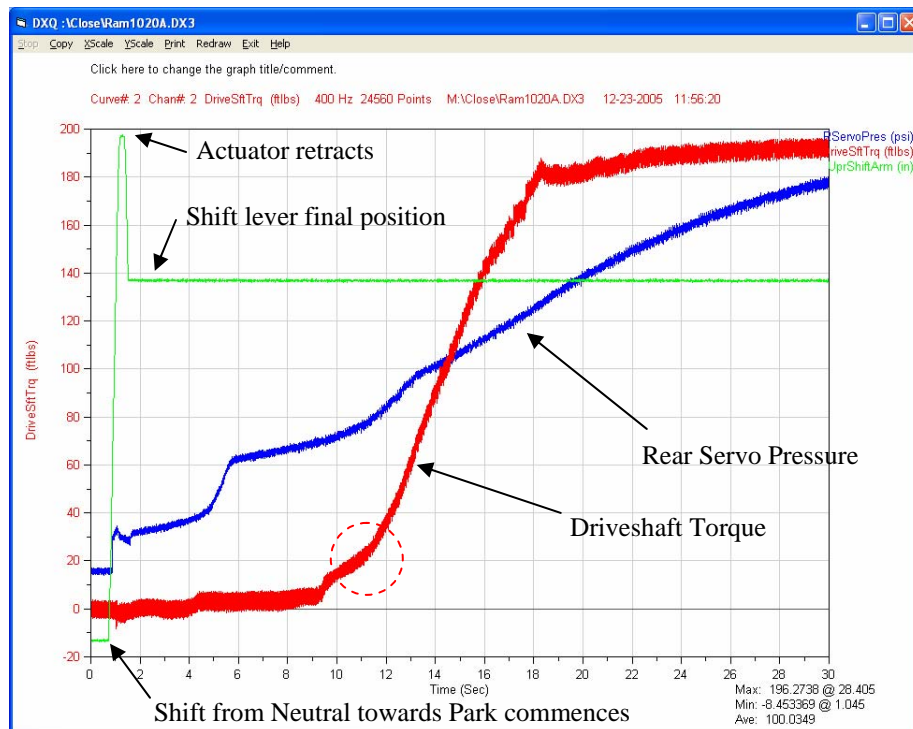
Figure 3: Subject Vehicle Shift Parameter data from VRTC testing

Figure 3, produced from data collected during VRTC testing, shows graphically how a valve bleed condition, due to an incomplete shift, effects engagement of hydraulic reverse. The green trace represents movement of the shift lever from the Neutral position towards Park; at time zero the shifter is in detent neutral. In the VRTC test, the shift lever tang was disabled and an electro-mechanical actuator moved the shift lever to a position between gated park and reverse and then retracted²⁴. The shift lever settles back to a stable position and remains there from approximately 2 seconds onward²⁵; this position results in a valve bleed condition within the valve body²⁶. At this time, the torque on the drive shaft (red trace) is zero and the pressure in the reverse servo (blue trace) shows an increasing trend due to the effects of the valve bleed condition²⁷. At approximately 9 seconds rearward torque begins to develop on the drive shaft as the rear servo pressure continues to increase. If the vehicle is on a flat and level surface (e.g., concrete), sufficient drive shaft torque (~ 20 – 25 ft. lbs.) exists to cause the vehicle to move rearward within approximately 11 or 12 seconds of the shift event. Torque continues to increase over the next 7 to 8 seconds as rear servo pressure increases and the transmission achieves full rearward torque (i.e., full hydraulic reverse) about 20 seconds after the shift; the vehicle is now fully powered in reverse.
